## TEST REPORT

Report No.: HC50038B/2024

Product Description: IP CAMERA Housing

Style/ Item No.: CC9380-HV-V2/ No.1

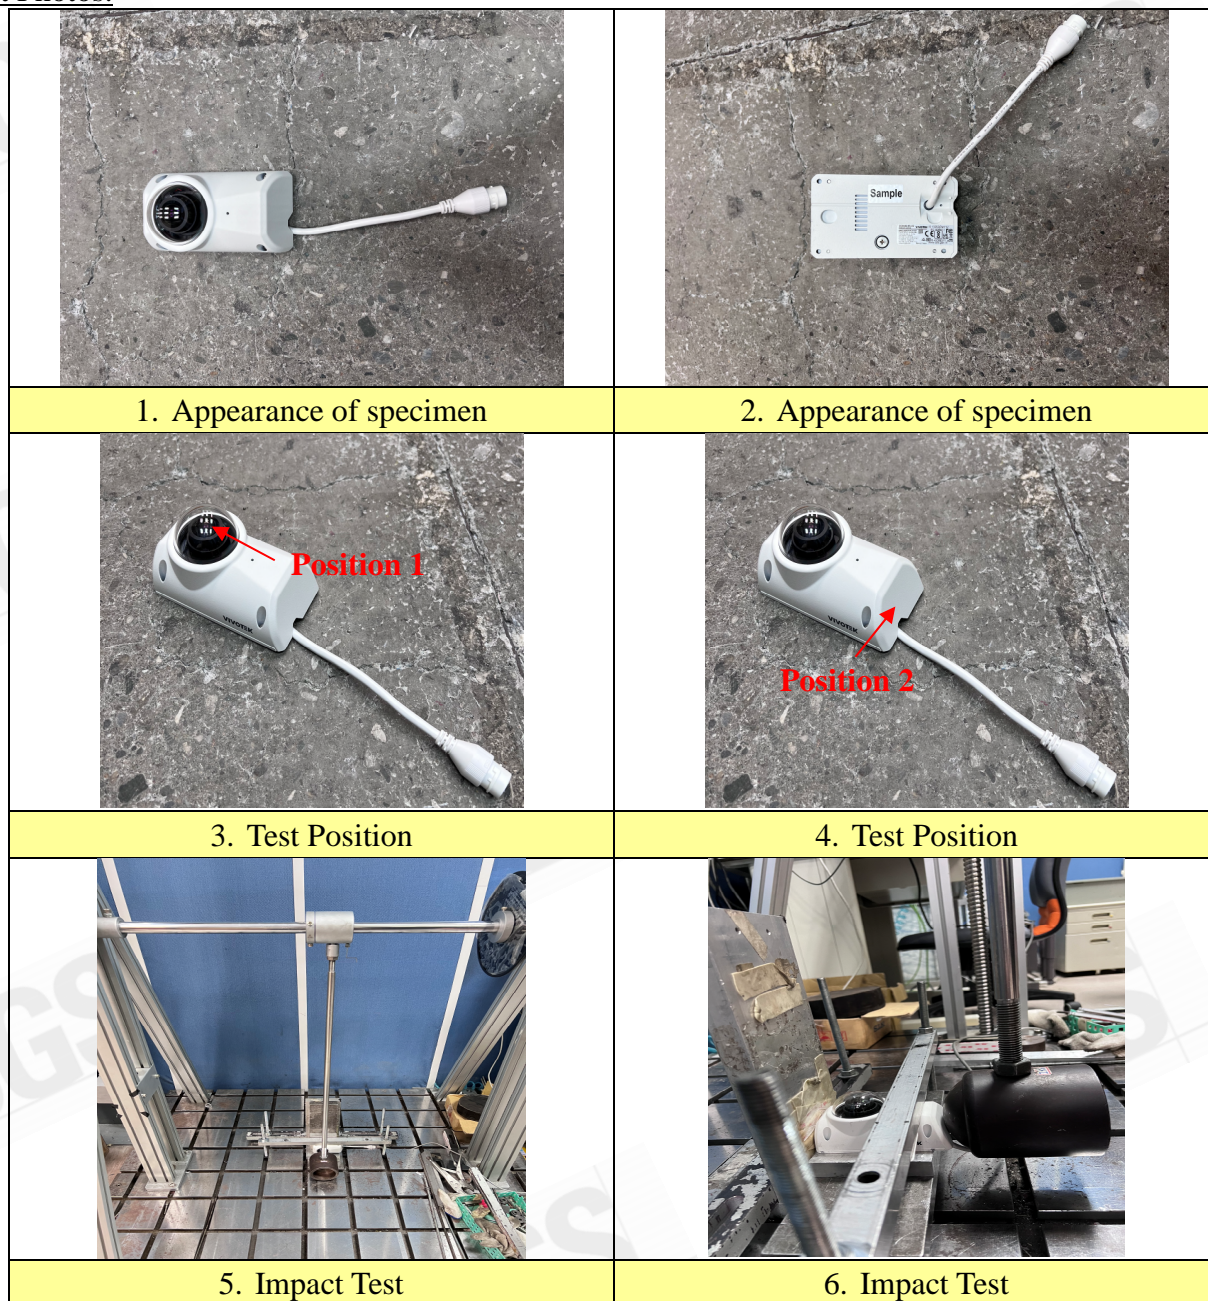
## Test Photos:

Test method: IEC 62262 Edition 1.1: 2021 -- IK10 and client's request  
Sample condition: Non-Operating  
Impact energy: 20 Joule  
Mass: 5 kg  
Impact height: 400 mm  
Test Position: Position 1, Position 2 (See photo 3, 4)  
No. of Impact: 1 impact/ Position  
Testing device: As shown in photo 5, 6

Check Item
Style/ Item No.	Test Position	Appearance Check (visual check)
CC9380-HV-V2/ No.1	Position 1	No visible damage
	Position 2	No visible damage
